# Final Project Report: RTU/Economizer Analysis and Field Assessment

*ET Project Number: ET17PGE1901*

**Project Manager:** Andy Doeschot  
Pacific Gas and Electric Company

**Issued:** November 16, 2021

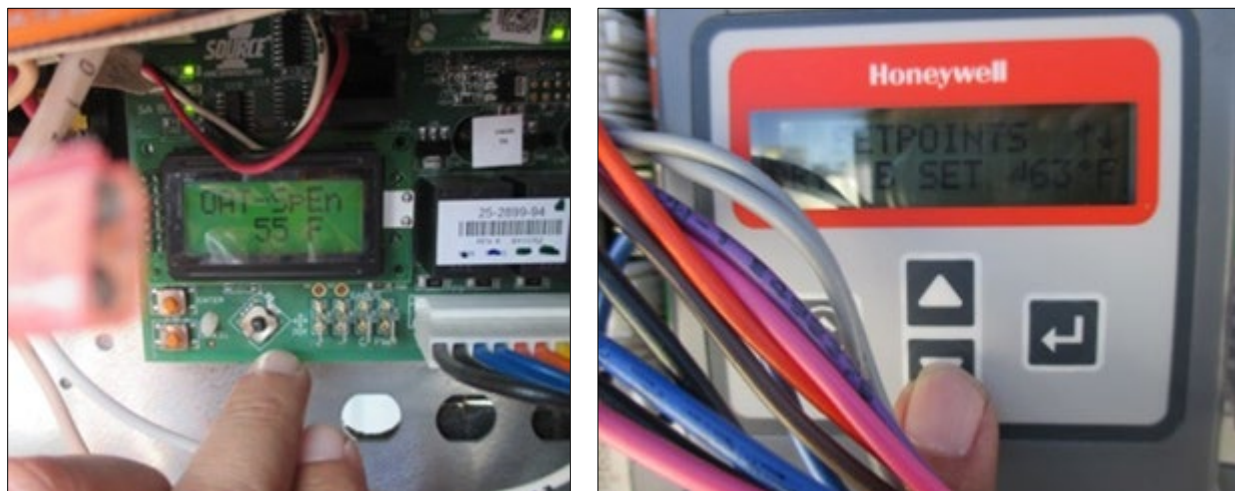
At the default setting, Jade systems will not economize above 63°F outside air and ECO systems will not economize above 55°F. These settings are not suitable for economizing in California's climate. The Study Team's onsite inspections typically occurred in late morning or early afternoon when the ambient temperatures were well above the default high-limit setpoints. As a result, the Study Team found all 16 units at their minimum positions during initial visual inspections and had to manipulate the outside air sensor below 63°F or 55°F to force the damper to modulate to 100% open. Figure 20 shows the typical default outdoor air high-limit setpoints.

**FIGURE 20: DEFAULT HIGH-LIMIT SETPOINTS – ECO AT 55°F (LEFT) & JADE AT 63°F (RIGHT)**

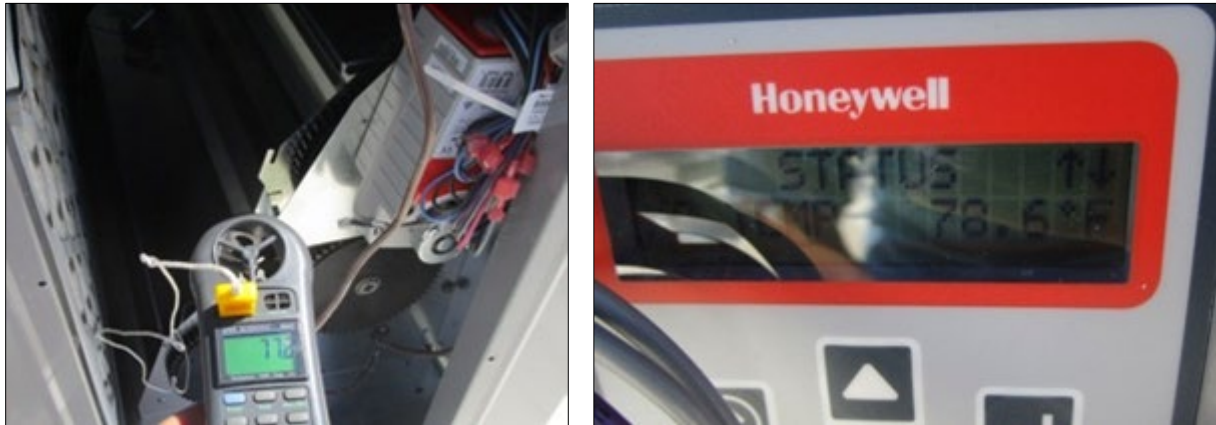
accurate. The field measurements typically matched the controller reported values to within  $\pm 2^{\circ}\text{F}$ . Overall, the investigation found the factory-provided sensor hardware properly calibrated and in good physical quality, which Figure 21 demonstrates, where the reported versus measured values are within  $1^{\circ}\text{F}$  of each other.

FIGURE 21: MIXED AIR SENSOR IN MIXED AIR PLENUM – FIELD AT  $77.8^{\circ}\text{F}$  (LEFT) VS. REPORTED AT  $78.6^{\circ}\text{F}$  (RIGHT)

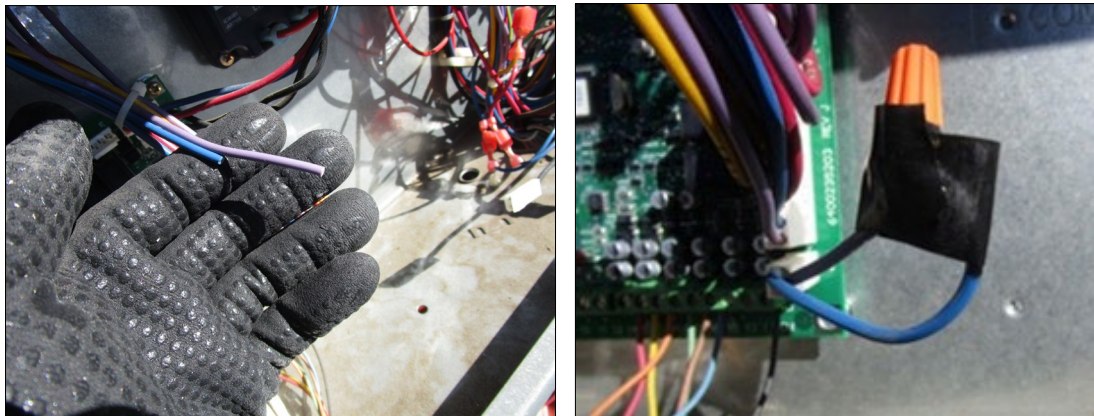
- At Site 6, there was no installation of either the sensor or its economizer controller within the RTU.
- At Site 11, the sensor was not connected to the controller. Figure 24 shows the outside air sensor installation problems at Site 11. The Study Team was able to find the sensor but found the link between the sensor and the control board was terminated. This site was a BMS integrated unit, but the economizer operation was not programmed.

FIGURE 24: SITE 11 OUTSIDE AIR SENSOR INPUT TERMINATED AT RTU CONTROL BOARD

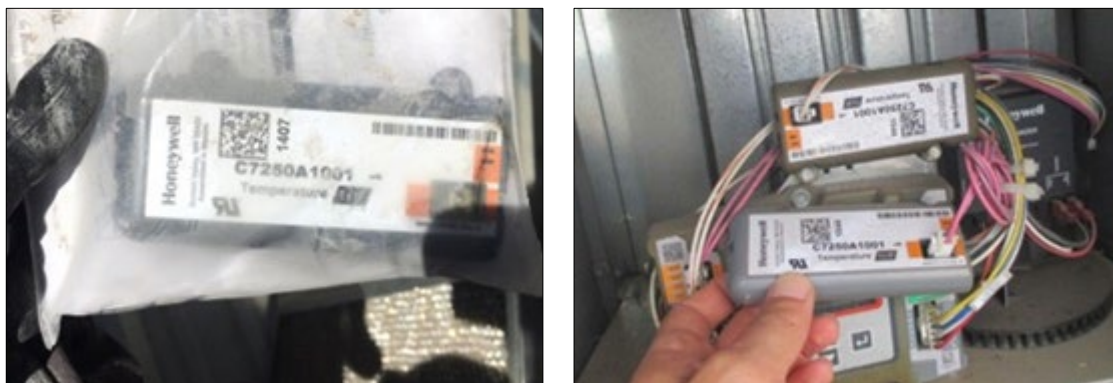
Figure 25 shows two different Jade economizer systems where the mixed air sensor was not installed.

**FIGURE 25: MIXED AIR SENSOR NOT INSTALLED – SITE 9 (LEFT) AND SITE 4 (RIGHT)**

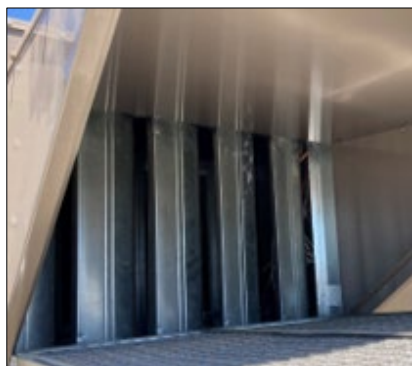
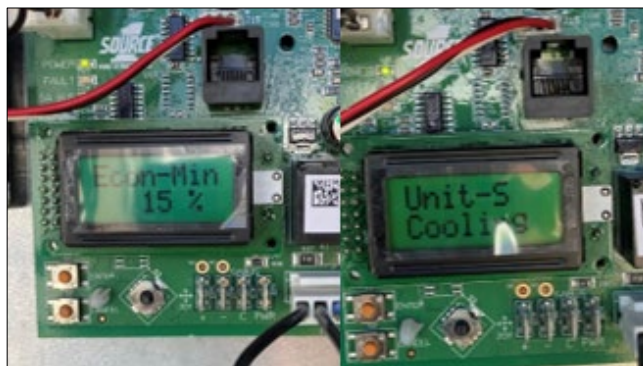
Figure 26 shows Site 15 as a typical example of a unit meeting Title 24 minimum ventilation requirements. As expected, the damper blades were slightly open, the corresponding menu display showed the minimum position programmed at 15% open, and since the outside air temperature was above the high-limit setpoint, the compressor was on in cooling mode.

**FIGURE 26: DAMPER AT MINIMUM POSITION (15%)**

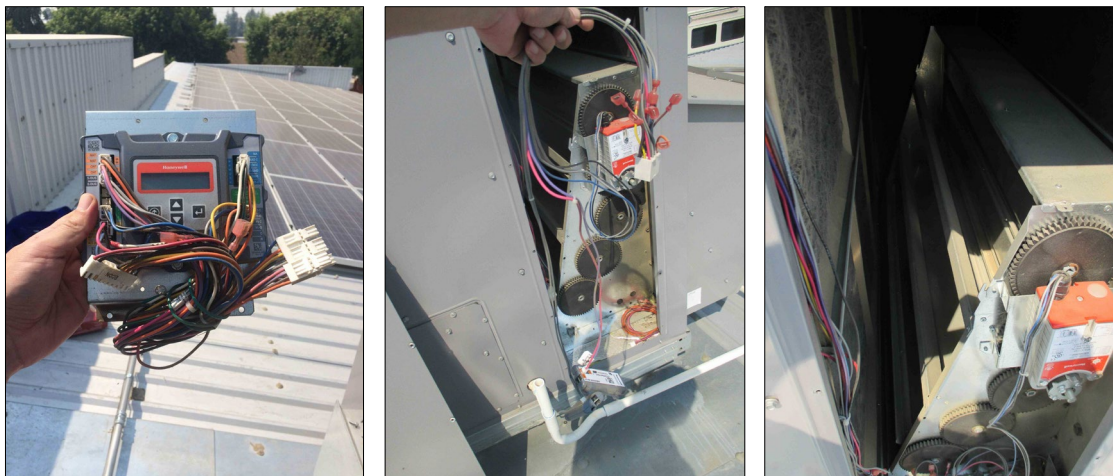
In Figure 27, the left image shows the as-found conditions where the Jade Controller was never installed, nor were its sensors and actuator connected. The Study Team was able to pull out the economizer system from the unit. The middle image shows the disconnected

actuator and sensors. The right image shows the outside air damper blades completely shut. Without any controls to the damper, the default position was failed closed.

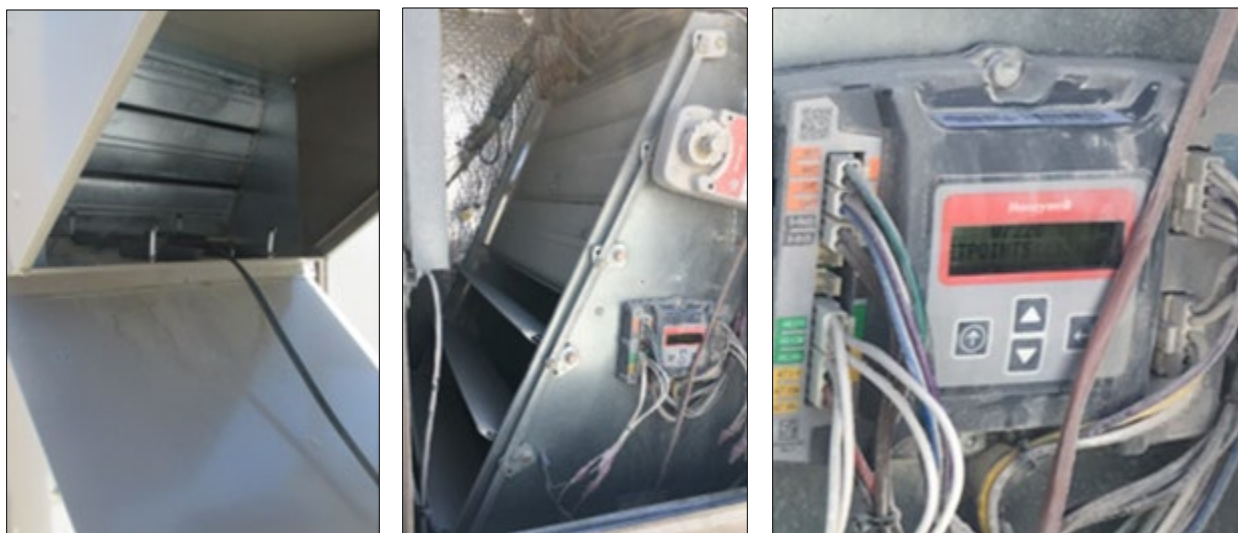
Figure 28 illustrates the minimum position programming failure found at Site 9. The unit was in operation and the economizer controller was installed and wired to the RTU's primary control board. During inspection, the outside air temperature was above the high-limit setpoint and unit was in cooling mode. However, instead of a minimum open position, the

outside air damper was closed and return damper was fully open. The configuration at all three Site 9 units was this way.

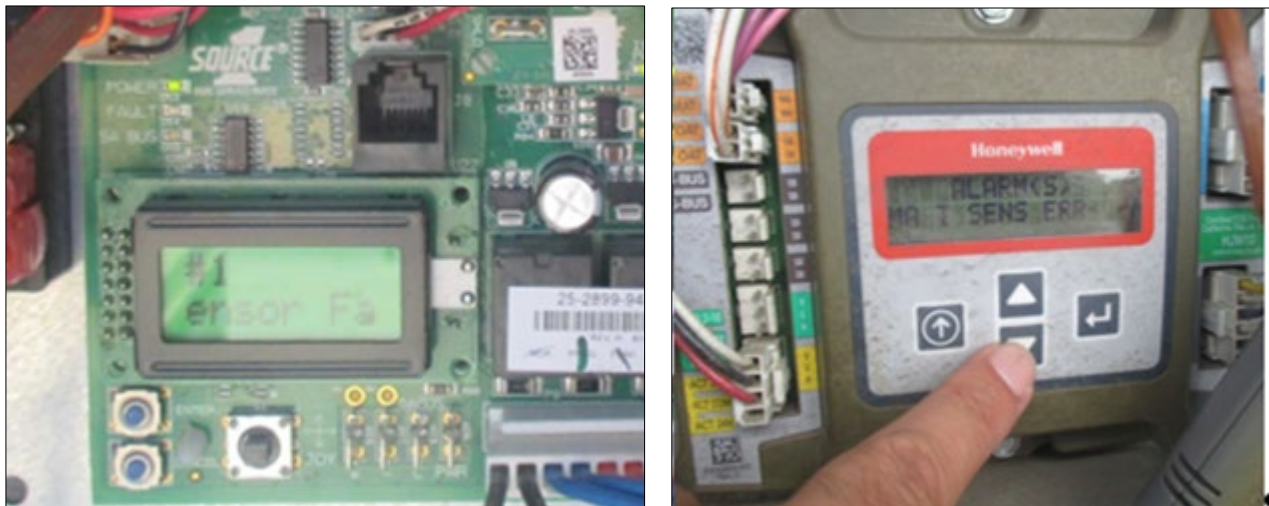
**FIGURE 30: ECO (LEFT) AND JADE (RIGHT) CONTROLLERS. BOTH DISPLAYING SENSOR ERROR ALARM FAULTS AS MIXED AIR SENSORS WERE NOT INSTALLED**

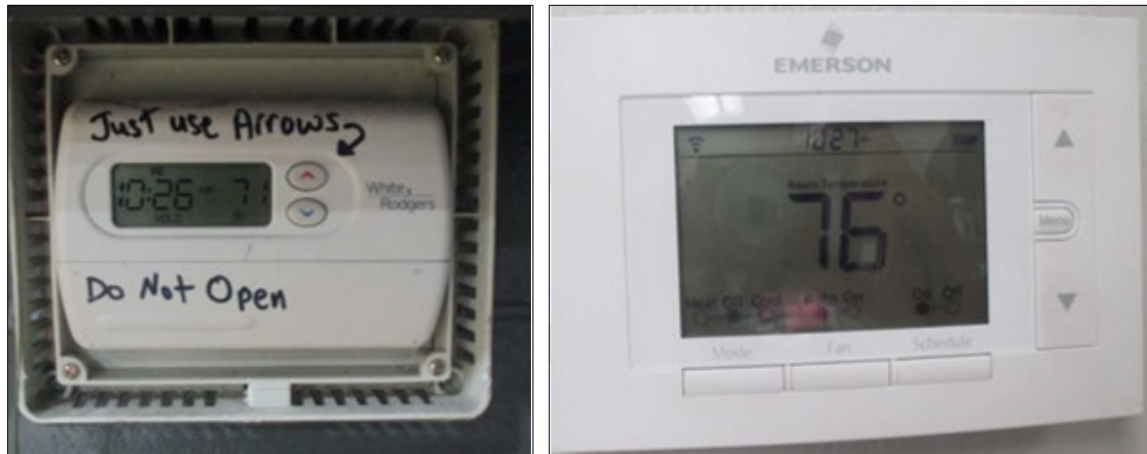
Figure 32 shows two typical, as-found thermostat conditions. They display room temperature and active mode (cooling, heating, or fan) but are not capable of displaying alarms. Both sites had active FDD alarms at the economizer controller due to missing sensors, but no alarms were annunciated at the zone level per code requirements. As a result, occupants were unaware that the units were in active alarm.

FIGURE 32: TYPICAL THERMOSTATS – SITE 2 (LEFT) AND SITE 4 (RIGHT). NO ALARMS DISPLAYED DESPITE ALARM CONDITIONS.

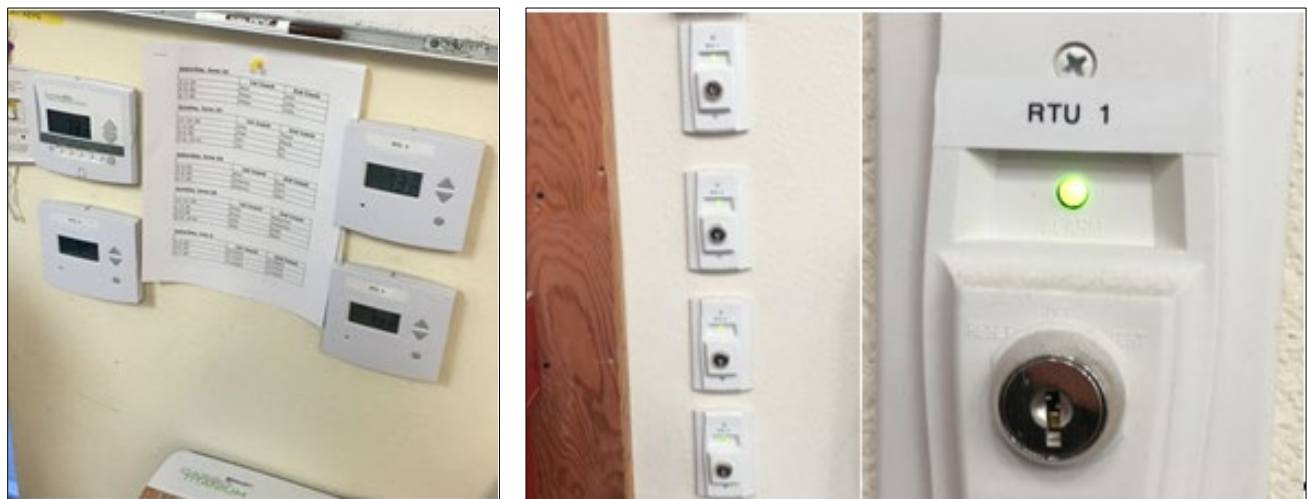
A common compliance approach found at sites with non-compliant thermostats was an auxiliary alarm sensor added to supplement the thermostat. This approach complied to the annunciated to the “device within five feet of the thermostat” clause. Figure 33 shows four thermostats and four corresponding supplemental alarm devices found at Site 9. All four alarms were found ‘active’ as indicated by their green display light. Site 9 had mixed air sensor alarms at the economizer controllers. However, it was unclear if the active alarms at zone level corresponded to same mixed air sensor alarm or other condition such as the ‘service filter’ alarm that was also found active. Furthermore, even though the auxiliary alarm sensor approach made this site compliant with FDD requirements, it did not appear to be effective at this site because the alarms had been active for quite some time.

**FIGURE 33: FOUR THERMOSTATS (LEFT) WITH FOUR CORRESPONDING SUPPLEMENTAL ALARM DISPLAYS (MIDDLE) AND ALARM IN “ACTIVE” MODE (RIGHT) AT SITE 9**

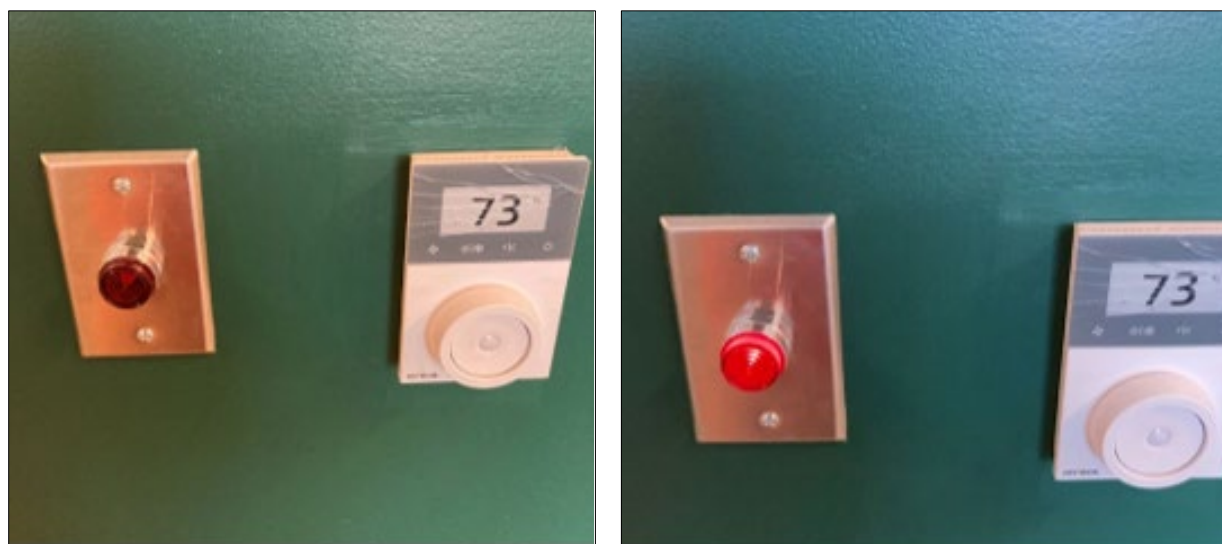
Figure 34 shows a similar configuration at Site 15, where an auxiliary alarm was added to comply with reporting requirement. The team created an alarm condition by unplugging the outside air sensor and observed the alarm turn active as indicated by red indicator light.

**FIGURE 34: RTU FDD TRIGGERED (LEFT), ALARM AT ZONE LEVEL ADJACENT T-STAT (RIGHT)**
