# Final Project Report: RTU/Economizer Analysis and Field Assessment

*ET Project Number: ET17PGE1901*

**Project Manager:** Andy Doeschot  
Pacific Gas and Electric Company

**Issued:** November 16, 2021

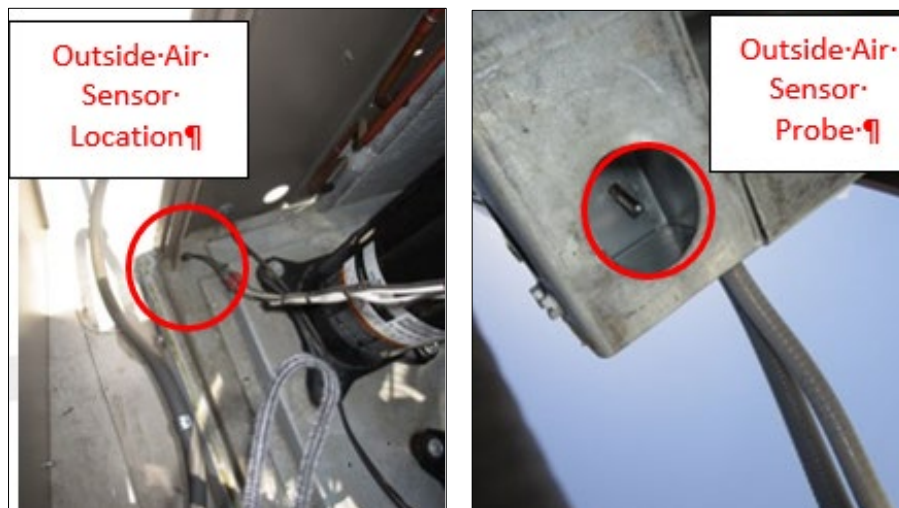
The field assessment found most outside air sensors connected to their controller and installed in an appropriate location. Figures 22 and 23 below illustrate common outside air sensor location placements. Figure 22 shows a typical ECO controller sensor installation. They are usually installed at the lower corner of the unit, through a drilled hole and exposed to the open air but shielded from direct sunlight or wind.

FIGURE 22: TYPICAL ECO OUTSIDE AIR SENSOR INSTALLATION – VIEW FROM TOP (LEFT) & VIEW FROM BOTTOM (RIGHT)

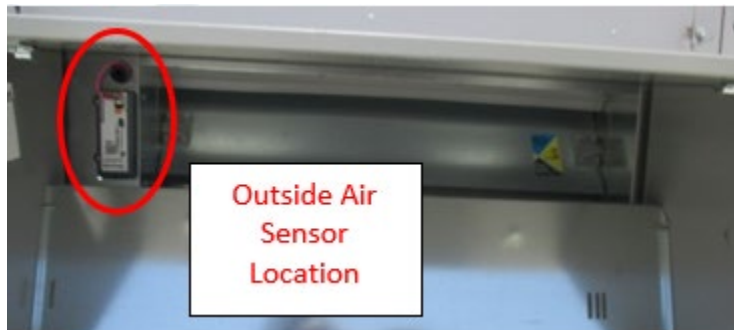
Figure 23 shows a typical Jade sensor installation. These are typically mounted to the unit near the outside air intake.

FIGURE 23: TYPICAL JADE OUTSIDE AIR INSTALLATION

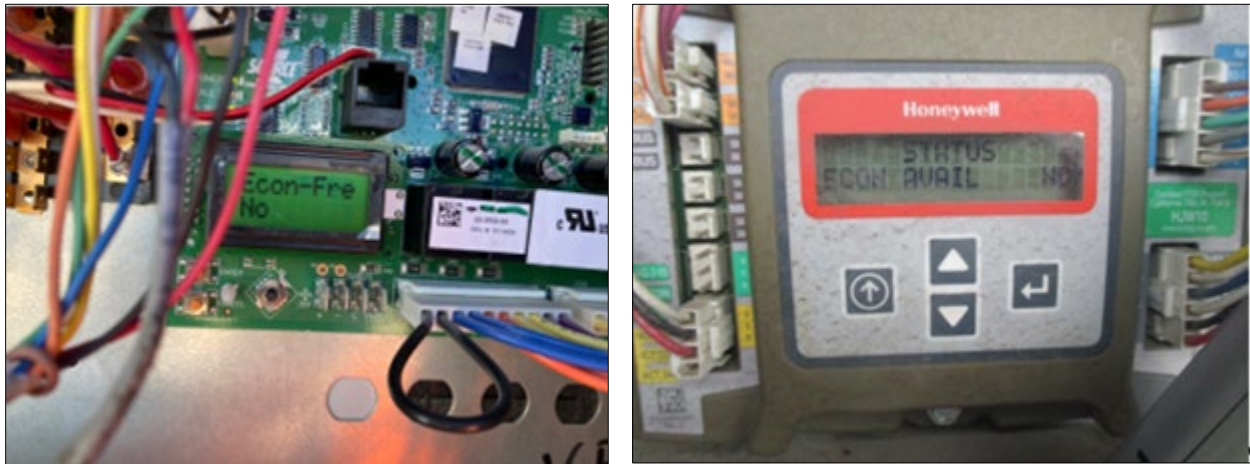
All stand-alone controllers met the system status and faults requirements. The Jade and ECO controllers come with factory-provided status and alarms that can be found by scrolling through the controller menu options, which Figure 29 and Figure 30 show.

**FIGURE 29: ECO (LEFT) AND JADE (RIGHT) CONTROLLERS DISPLAYING ECONOMIZER STATUS. BOTH SHOW NO ECONOMIZING AVAILABLE DUE TO OUTSIDE AIR TEMPERATURE ABOVE THEIR RESPECTIVE HIGH-LIMIT SETPOINTS.**

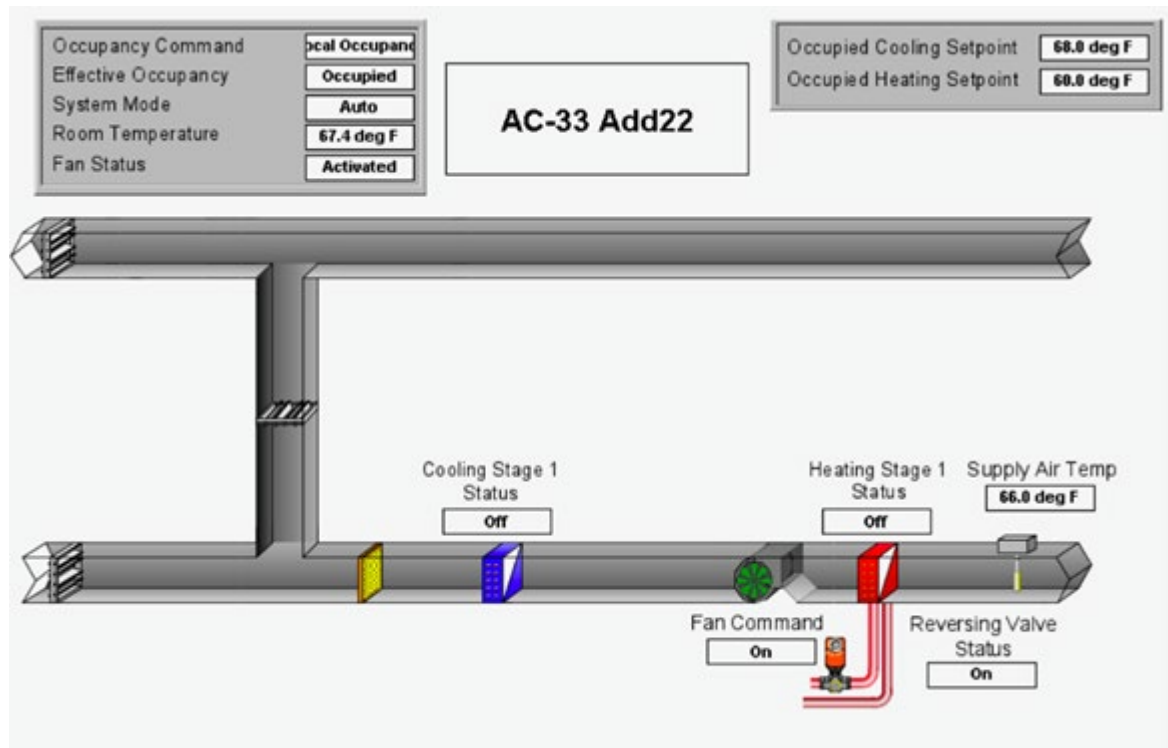
The BMS systems typically displayed current system status through their graphic interface, which Figure 31 depicts, but typically did not have any alarms programmed, and thus had nothing to report to the BMS.

FIGURE 31: TYPICAL BMS GRAPHIC WITH COOLING, HEATING AND FAN STATUS

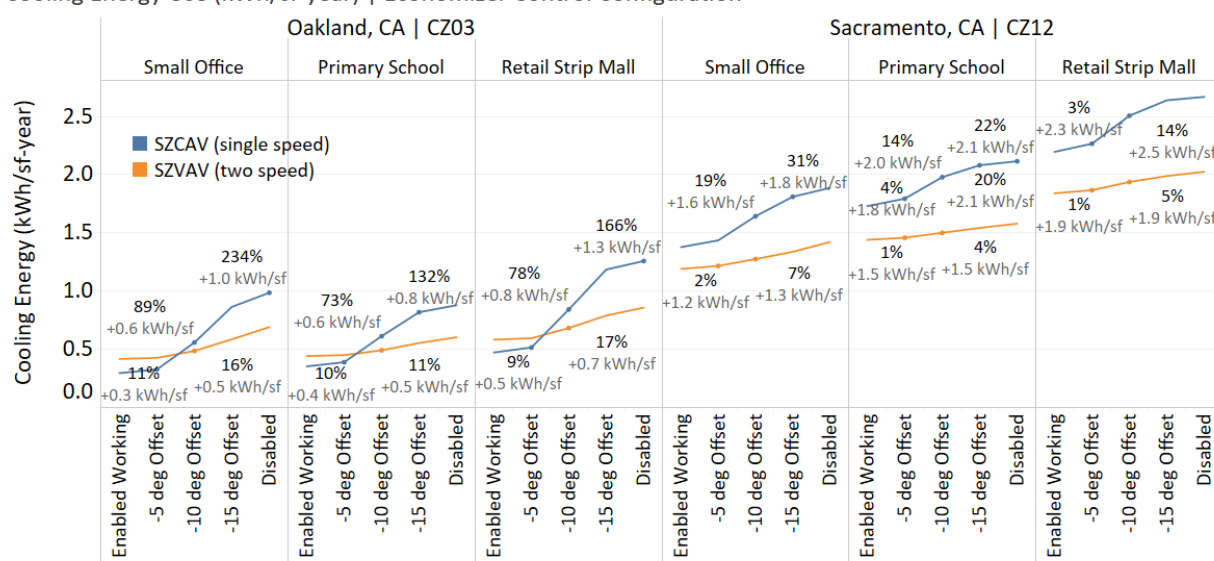
Figure 35 shows the result for each building and two types of RTU/economizer units, one with a single speed and one with two speeds, in CZ03 and CZ12. CZ03 shows the greatest relative change to cooling energy, with the upper limit by -15°F increases cooling energy by 193% in single-speed RTUs and 40% in two-speed RTUs.<sup>19</sup>

FIGURE 35: ENERGY MODELING RESULTS FOR ECONOMIZER CONTROL CONFIGURATION FAULT OF TOTAL COOLING ENERGY CONSUMPTION (kWh/sf-year), CZ03 AND CZ12

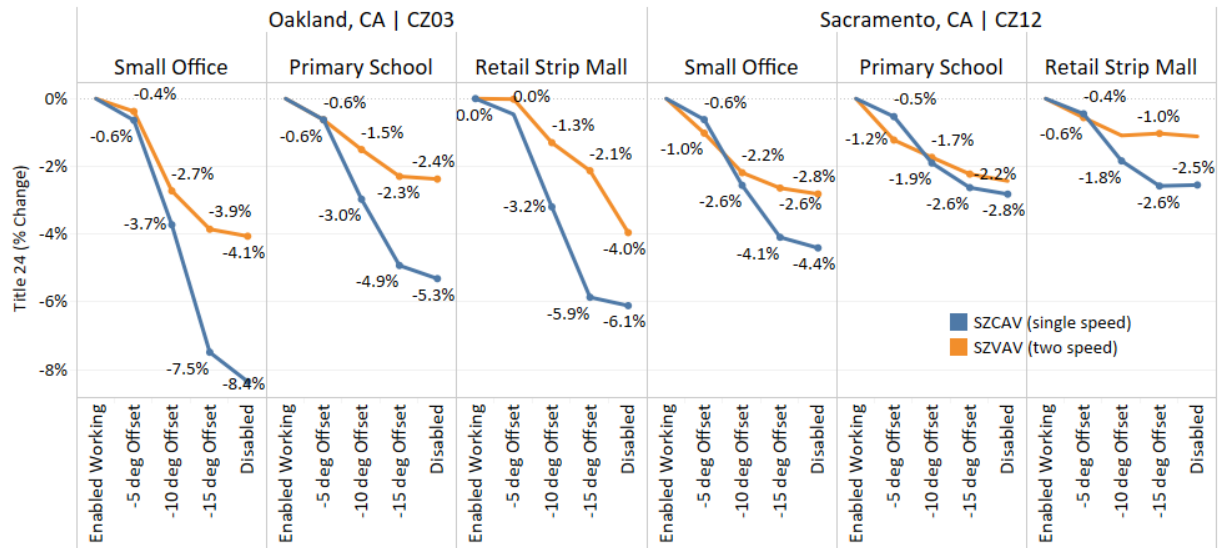
Figure 36 shows the resulting change in energy code compliance for each building (new construction), temperature offset, and RTU/economizer type in two climate zones. As an example, small offices in a mild climate, like CZ03, with single speed RTUs show a code compliance reduction of 7.5% at -15°F offset.<sup>20</sup>

**FIGURE 36: ENERGY MODELING RESULTS FOR ECONOMIZER CONTROL CONFIGURATION FAULT IN CHANGE IN CODE COMPLIANCE (% TDV), CZ03 AND CZ12**

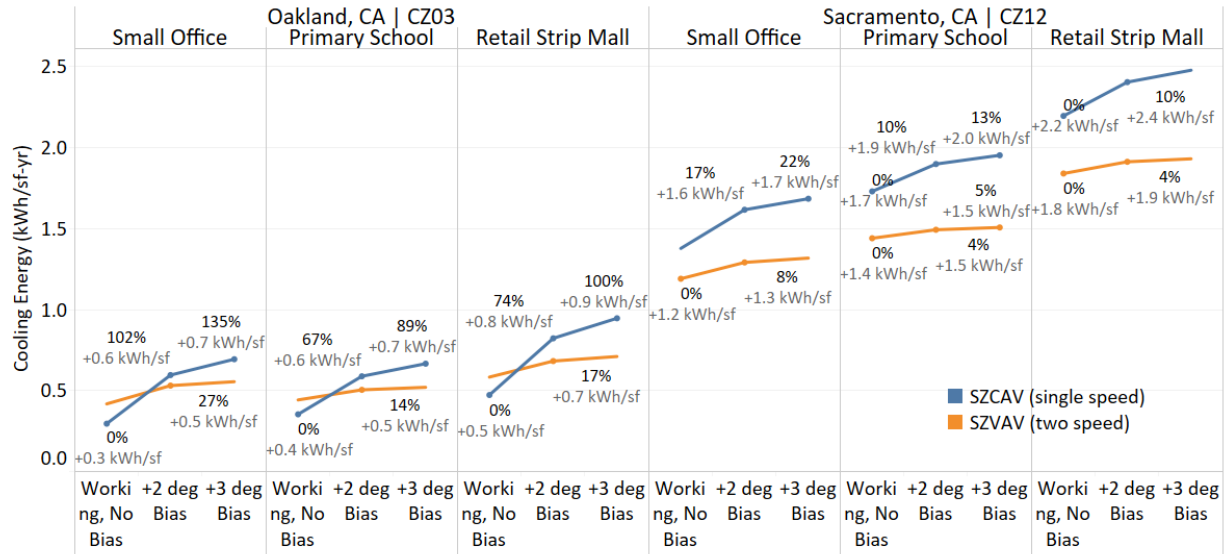
**FIGURE 37: ENERGY MODELING RESULTS FOR MIXED AIR TEMPERATURE SENSOR FAULT OF TOTAL COOLING ENERGY CONSUMPTION (kWh/sf-year)**

In mild climates where a large portion of cooling is provided by economizing, the relative impact is quite high, with cooling energy increasing by 89% to 135% in single speed RTUs in the 3 degree bias scenario. In warmer climates, where cooling is only partially provided by economizing, the relative impact was lower, 13% to 22% increases for single speed RTUs, though the nominal cooling energy use overall increased by higher margins, between 1.7 and 2.4 kWh/sf-year compared to 0.7 to 0.9 kWh/sf-year. Figure 38 shows the same fault parameter impact on energy code compliance.

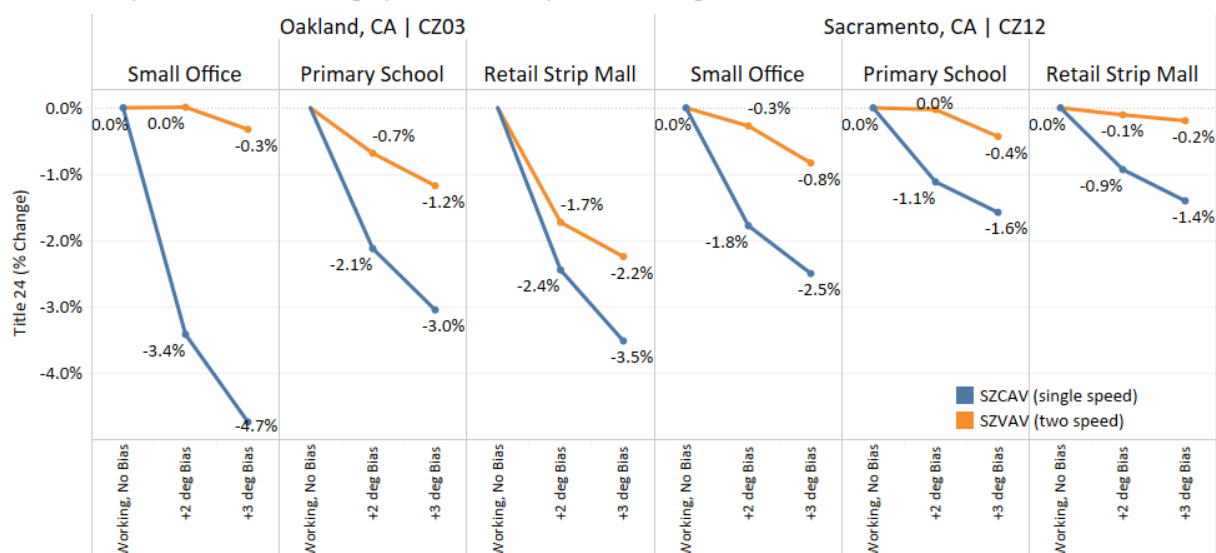
**FIGURE 38: ENERGY MODELING RESULTS FOR MIXED AIR TEMPERATURE SENSOR BIAS FAULT IN CHANGE IN CODE COMPLIANCE (% TDV)**

Figure 38 shows the impacts on code compliance of the mixed air temperature location in single and two-speed RTUs. In the retail strip mall building, a 3°F bias reduced the buildings margin of code compliance by -2.2% with a two-speed RTU and -3.5% with a single-speed RTU in Oakland, CA (CZ03). The figure shows similar but smaller relative impacts in the warmer climate, Sacramento, CA (CZ12).

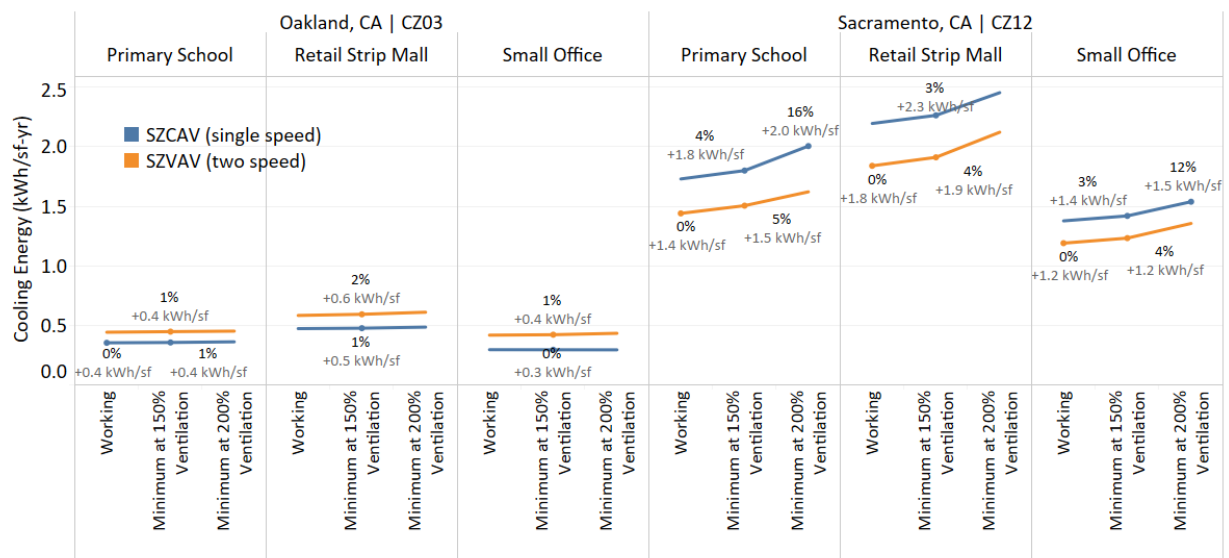
**FIGURE 39: ENERGY MODELING RESULTS FOR MINIMUM OUTDOOR AIR FRACTION FAULT IN INCREMENTAL ELECTRICAL ENERGY (KWH/SF-YEAR)**

Figure 39 shows that only warmer climates experienced a substantive change in cooling energy use. Figure 40 evaluates the same minimum outdoor air control faults for code compliance and utilizing the life-cycle-energy-cost metric TDV; each building and climate zone see substantial changes in the margin of percent savings, with all single speed RTU results showing -15% or lower and two-speed RTUs -20% or lower. The analysis shown in Figure 40 is for two-speed RTUs with control faults versus two-speed RTUs without control faults.

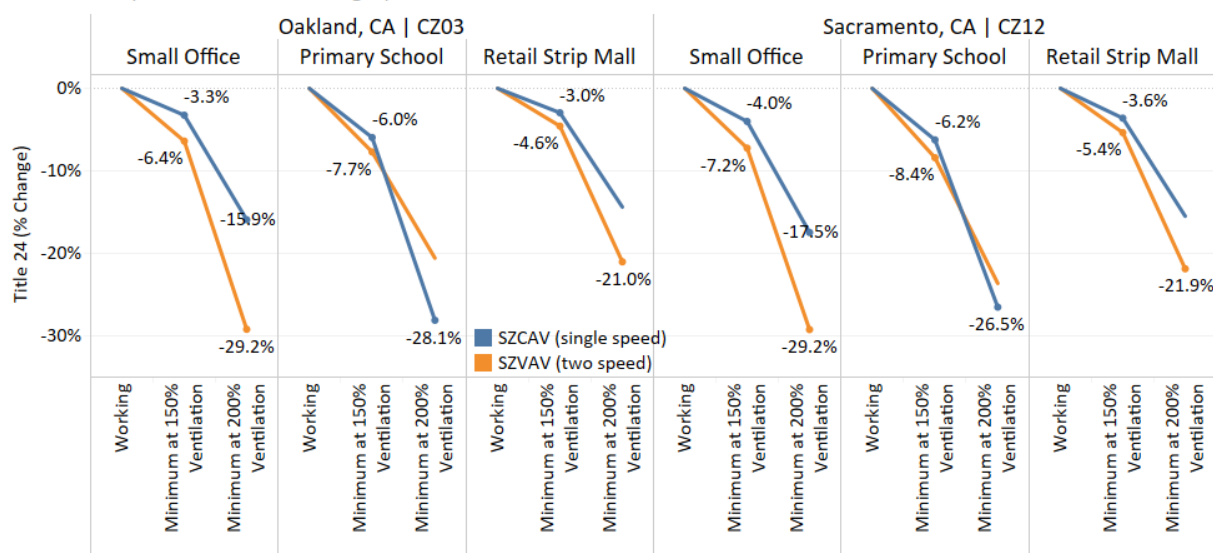
**FIGURE 40: ENERGY MODELING RESULTS FOR MINIMUM OUTDOOR AIR FRACTION FAULT IN CHANGE IN CODE COMPLIANCE (% TDV)**

The code compliance life cycle cost metric, TDV, weights hours of energy use more heavily during peak hours on the electrical grid than off peak hours. The analysis results indicate that the economizer control fault and the mixed air sensor bias cause relatively small changes in TDV as a percent of total energy since both of these faults tend to increase cooling energy during off peak hours. The higher minimum outdoor air fault results in an increase in cooling and heating energy during all times of the day, both on peak and off peak hours, resulting in largest change in TDV as a percentage of the three faults evaluated. Over the life cycle of these RTU/economizer units, those with problematic dampers and excess outdoor air will see the highest operating cost impacts of the three faults evaluated.

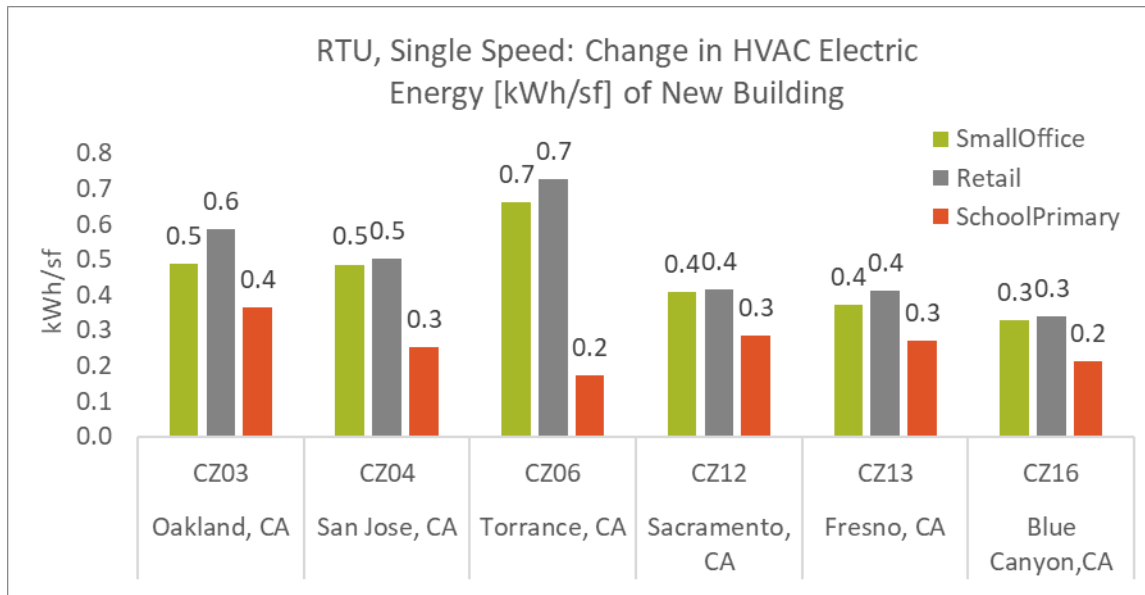
This second step of the analysis shows an increase in RTU/economizer electrical energy use from increased cooling for the three building prototypes. Figure 41 and Figure 42 show results for single-speed RTUs and two-speed RTUs. RTU/economizers performance was most impacted in mild climates where more hours of economizing potential exist; the highest increase in energy use was in CZ06 (Torrance, CA). In Torrance, CA, the single speed RTU energy use would increase by 9% RTU/economizer electrical energy use, 0.5 kWh/sf-yr.

**FIGURE 41: WEIGHTED AVERAGE INCREASE IN HVAC ELECTRICITY USE BASED ON FIELD INSPECTION FAULT OCCURRENCES, SINGLE SPEED RTUs**

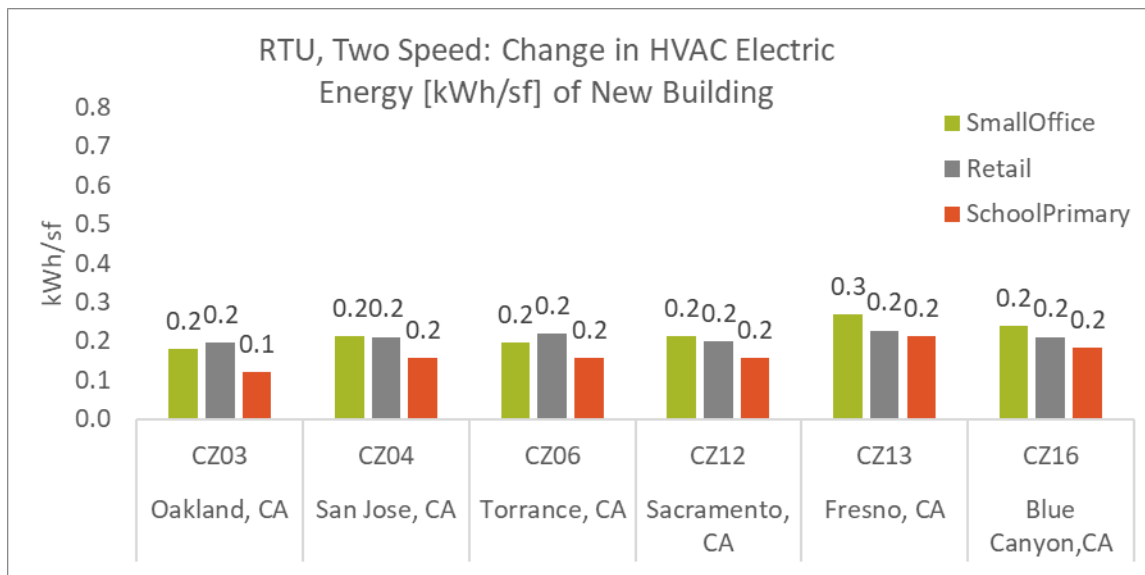
**FIGURE 42: WEIGHTED AVERAGE INCREASE IN HVAC ELECTRICITY USE BASED ON FIELD INSPECTION FAULT OCCURRENCES, TWO SPEED RTUs**

The Study found that two-speed RTUs had a lower increase in energy use than single-speed RTUs and have more similar nominal impacts across building types and climate regions. On average, two-speed RTUs saw an increase in energy use of 0.2 kWh/sf, with the highest increase being 0.3 kWh/sf. This finding suggests that requiring a wider range of RTU systems to include two-speed fan and two-speed compressor capabilities would reduce the increased energy usage impacts of economizer operational faults.

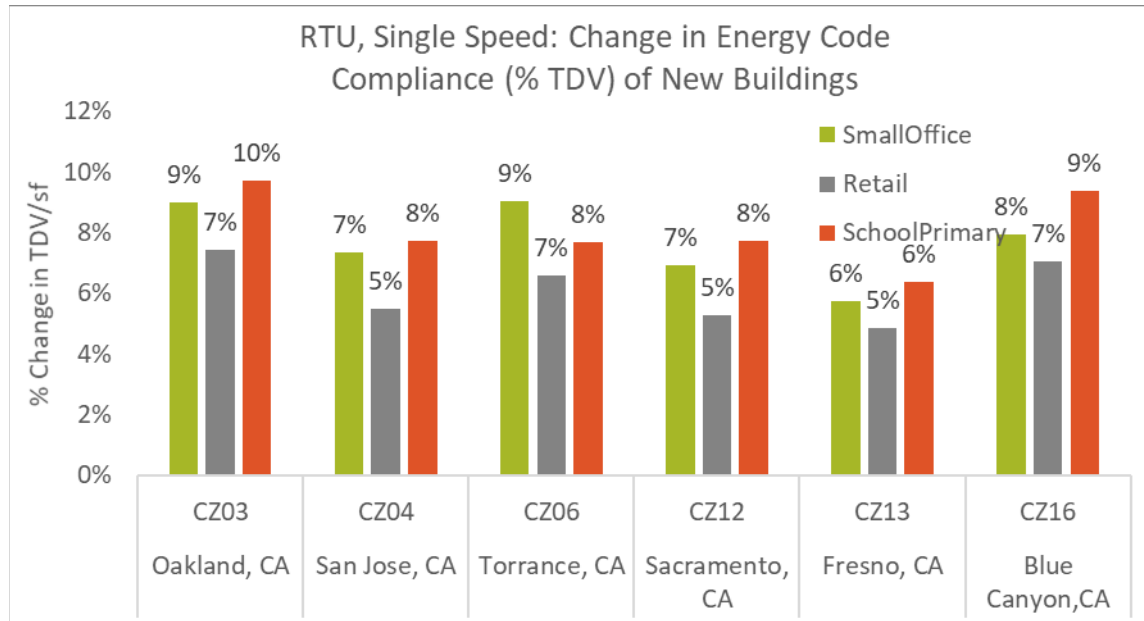
Figure 43 and Figure 44 show the impacts on energy code compliance of the modeled frequency of fault parameters. For single speed RTUs, the weighted average reduction in code compliance across climate zones and building types was 6%, with a range of 5% and 10% for the three building types. Mild climates, such as Oakland CA, CZ03, show the highest change in code compliance with a 10% reduction for the small school prototype.

**FIGURE 43: WEIGHTED AVERAGE DECREASE IN CODE COMPLIANCE PERCENTAGE BASED ON FIELD INSPECTION FAULT OCCURRENCES, SINGLE SPEED RTUs**

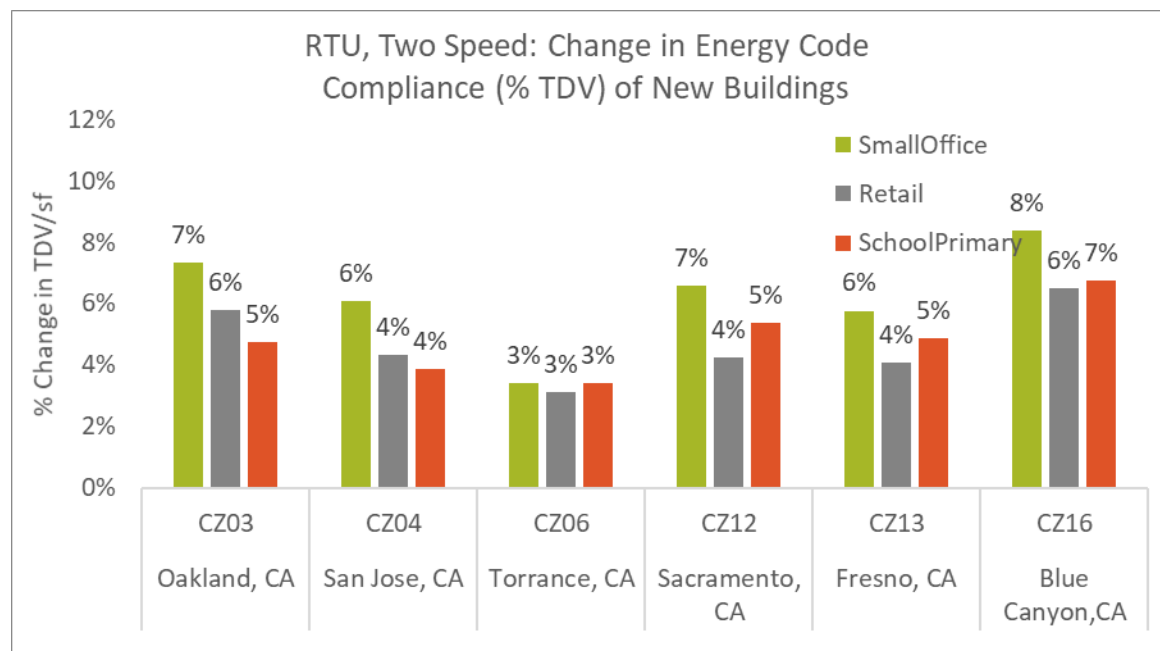
In two-speed RTUs, the impact was lower, with an average reduction in energy code compliance of 5%, with a range of 3% to 8% for the three building types.

**FIGURE 44: WEIGHTED AVERAGE DECREASE IN CODE COMPLIANCE PERCENTAGE BASED ON FIELD INSPECTION FAULT OCCURRENCES, TWO-SPEED RTUs**

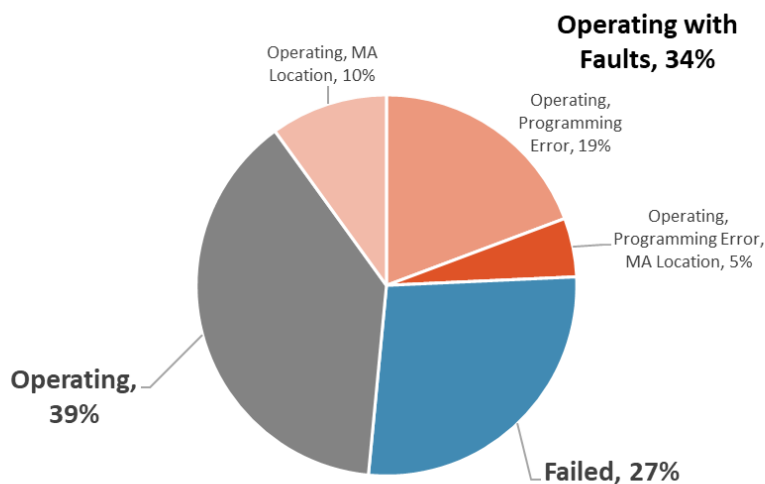
**FIGURE 45: THE PERCENT OF UNITS ON A TYPICAL BUILDING WITH RTUs ESTIMATED TO BE OPERATIONAL, OPERATIONAL WITH FAULTS, AND DISABLED WITH REGARDS TO THE ECONOMIZERS**

The result of extrapolating the Study observations with the HVAC 1 study findings was that 39% of units are assumed to operate as intended, 34% of units operate with faults, and 27% of units operate with disabled or nonoperational economizers as shown in Figure 45 demonstrates. The Study applied these percentages to the simulated energy modeled scenarios and combined them to estimate the average per-building and per-climate zone impact on operational energy. Figure 46 through Figure 49 present the results. In all figures, positive numbers show the energy increase and labels indicate the absolute and relative increase.

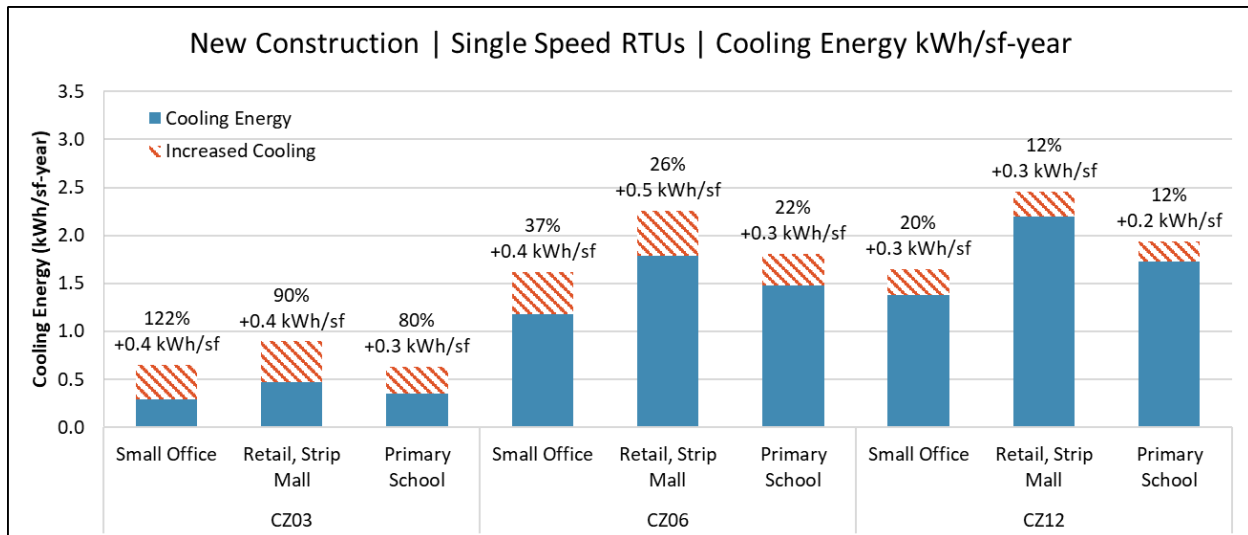
**FIGURE 46: WEIGHTED AVERAGE INCREASE IN COOLING ELECTRICAL ENERGY USE BASED ON STUDY RESULTS EXTRAPOLATED WITH HVAC 1 DATA, SINGLE-SPEED RTUs, CZ03, CZ06, AND CZ12**

The average increase in cooling electrical energy for a building with an RTU/economizer across the 6 climate zones was 34% for single-speed RTUs and 11% for two-speed RTUs compared to expected RTU/economizer operation.

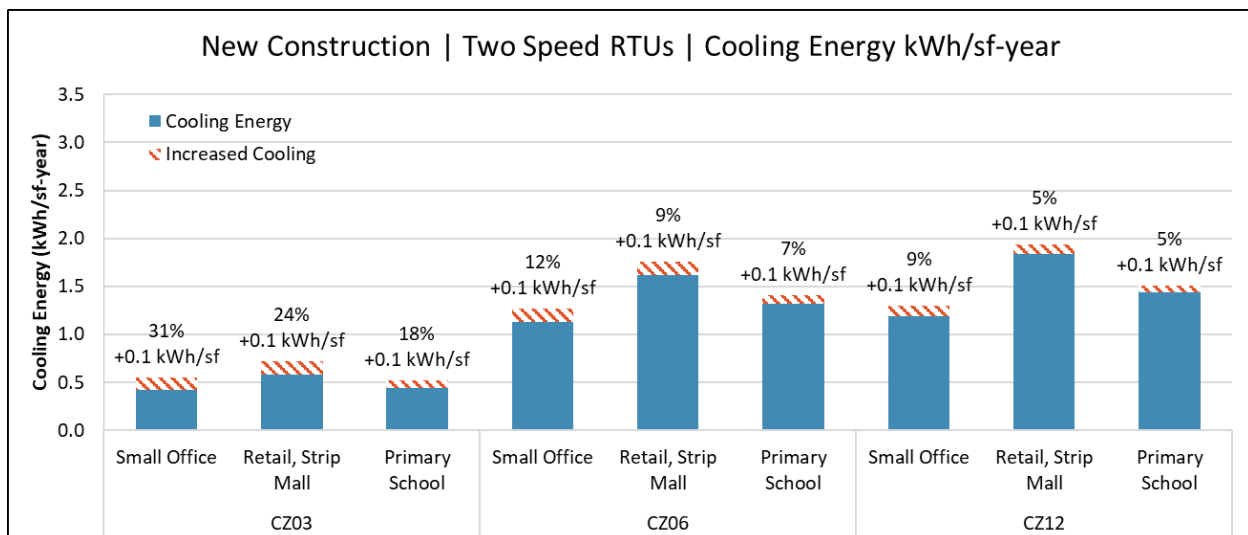
**FIGURE 47: WEIGHTED AVERAGE INCREASE IN COOLING ELECTRICAL ENERGY USE BASED ON STUDY RESULTS EXTRAPOLATED WITH HVAC 1 DATA, TWO-SPEED RTUs, CZ03, CZ06, AND CZ12**

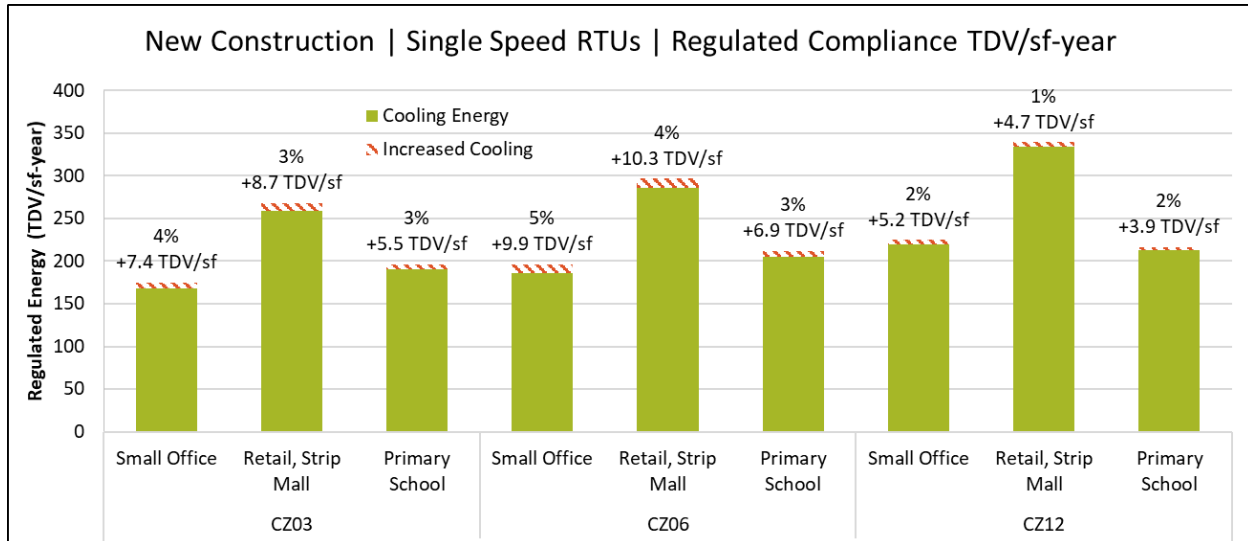
**FIGURE 48: WEIGHTED AVERAGE INCREASE IN CODE COMPLIANCE MARGIN TO TITLE 24 2019, BASED ON STUDY FIELD INSPECTION EXTRAPOLATED WITH HVAC 1 STUDY RESULTS, SINGLE-SPEED RTUs, CZ03, CZ06, AND CZ12**

Figure 48 and Figure 49 show the impacts on regulated energy, evaluated with the life cycle cost metric, TDV. Across the six climate zones and three prototype buildings, regulated energy increased by 3% for single-speed RTUs and by 1% in two-speed RTUs.

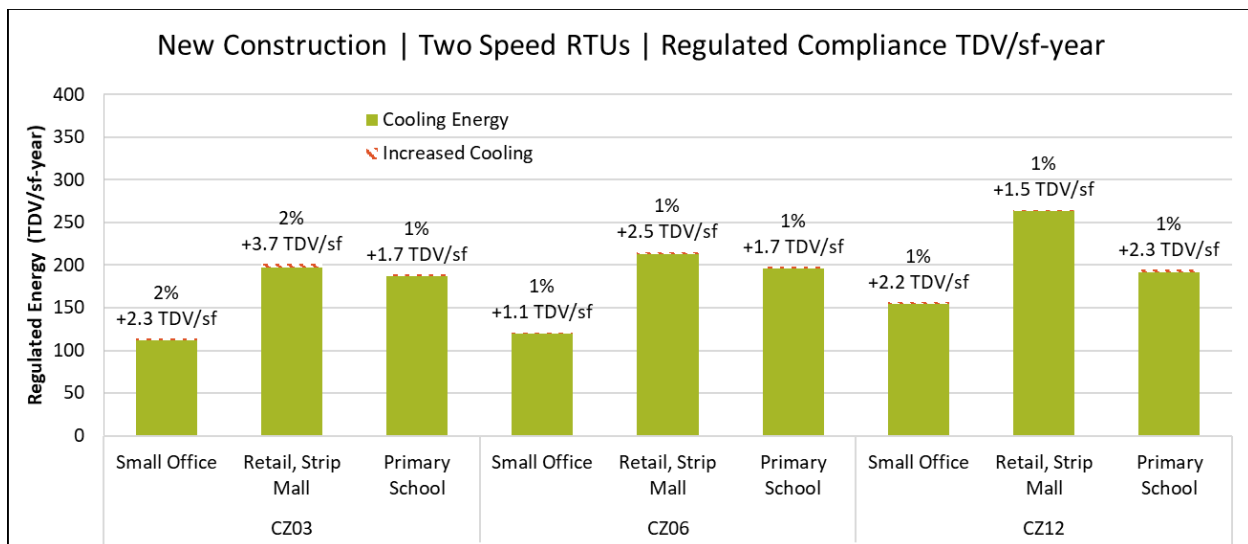
**FIGURE 49: WEIGHTED AVERAGE INCREASE IN CODE COMPLIANCE MARGIN TO TITLE 24 2019 BASED ON STUDY FIELD INSPECTION EXTRAPOLATED WITH HVAC 1 STUDY RESULTS, TWO-SPEED RTUs, CZ03, CZ06, AND CZ12**
